**PROJECT FOCUS**

# Indoor Pool with Slide & Waterfall

Captures Feel of Tuscany in Elegant Setting

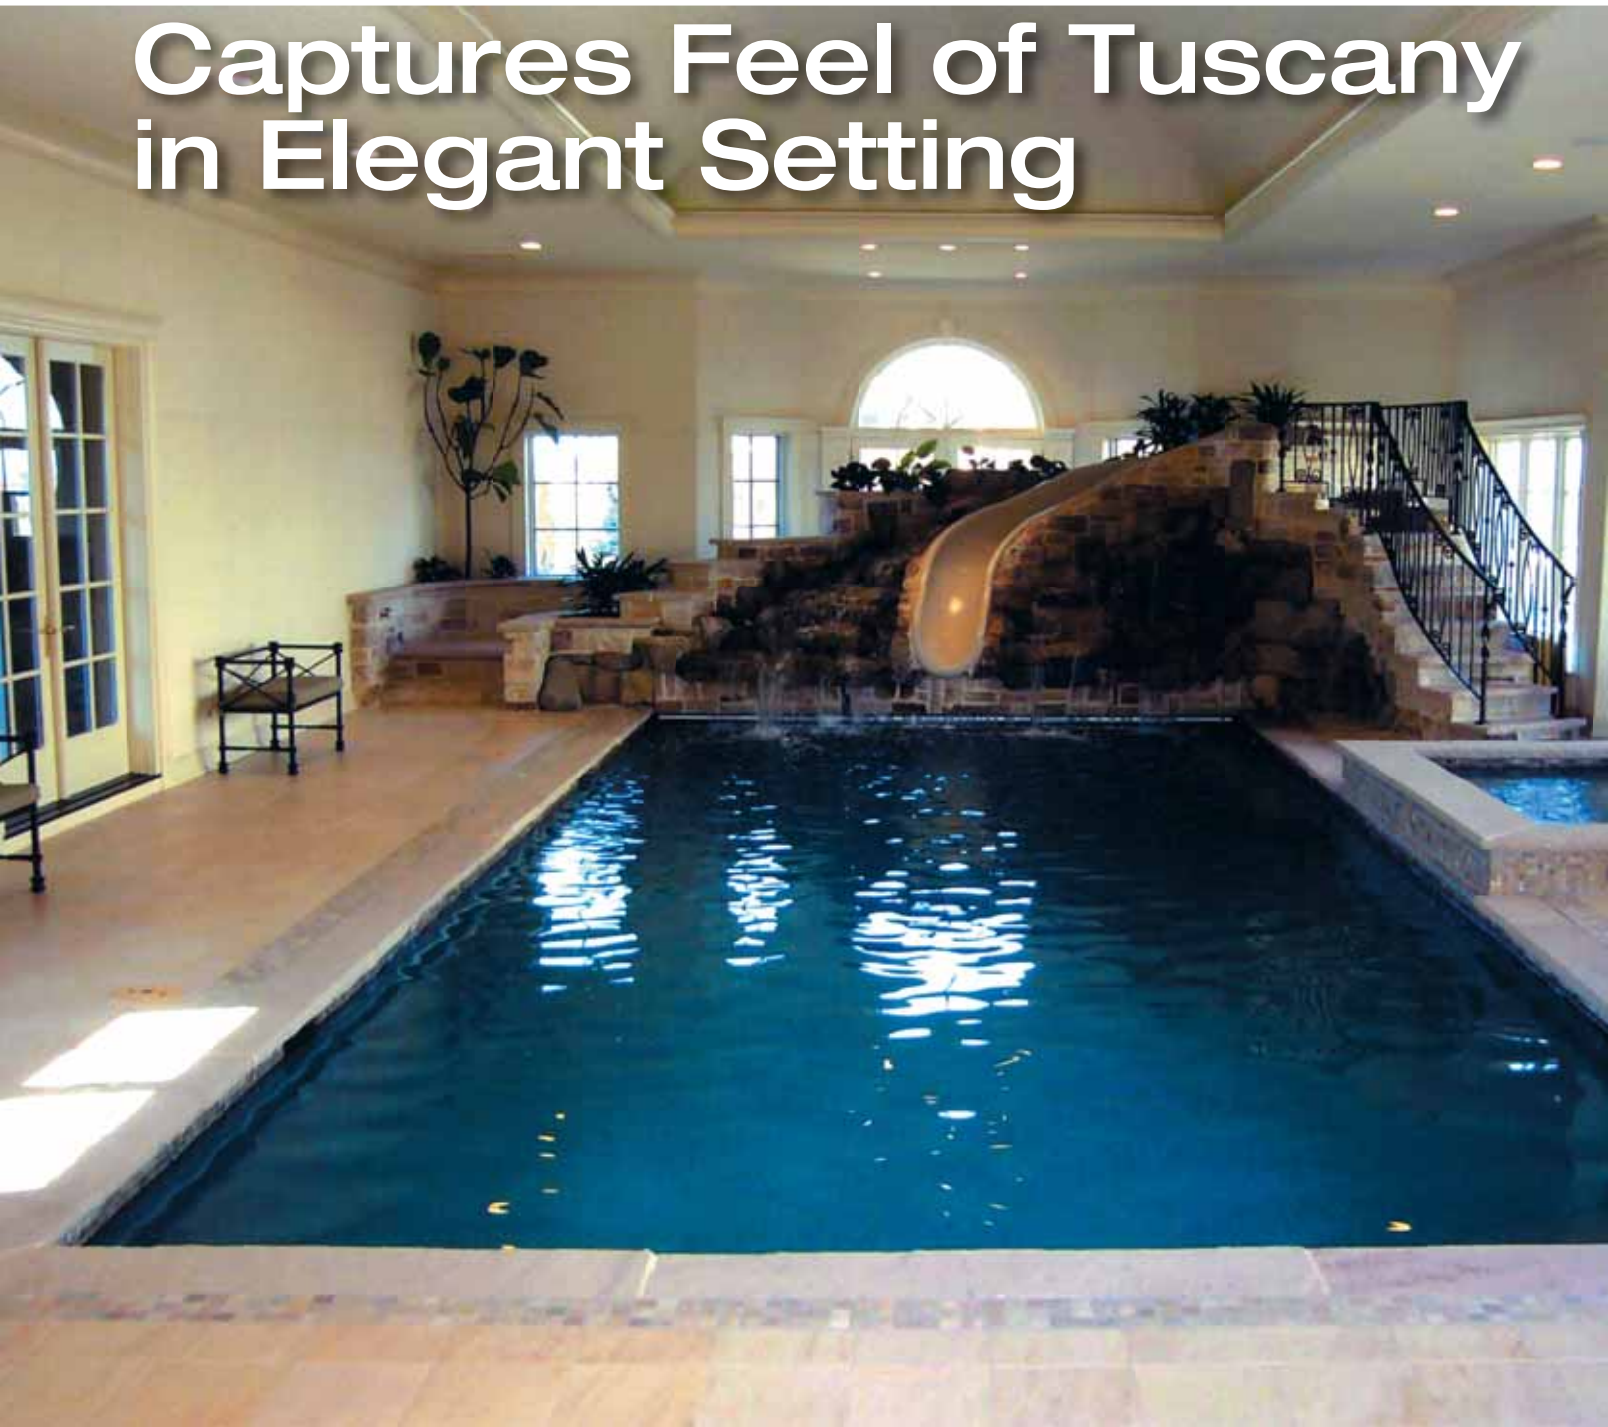
*The waterfall floor is framed out, corrugated steel installed and rebar reinforced to support the waterfall and slide structure. There are structural steel beams below the support framing.*

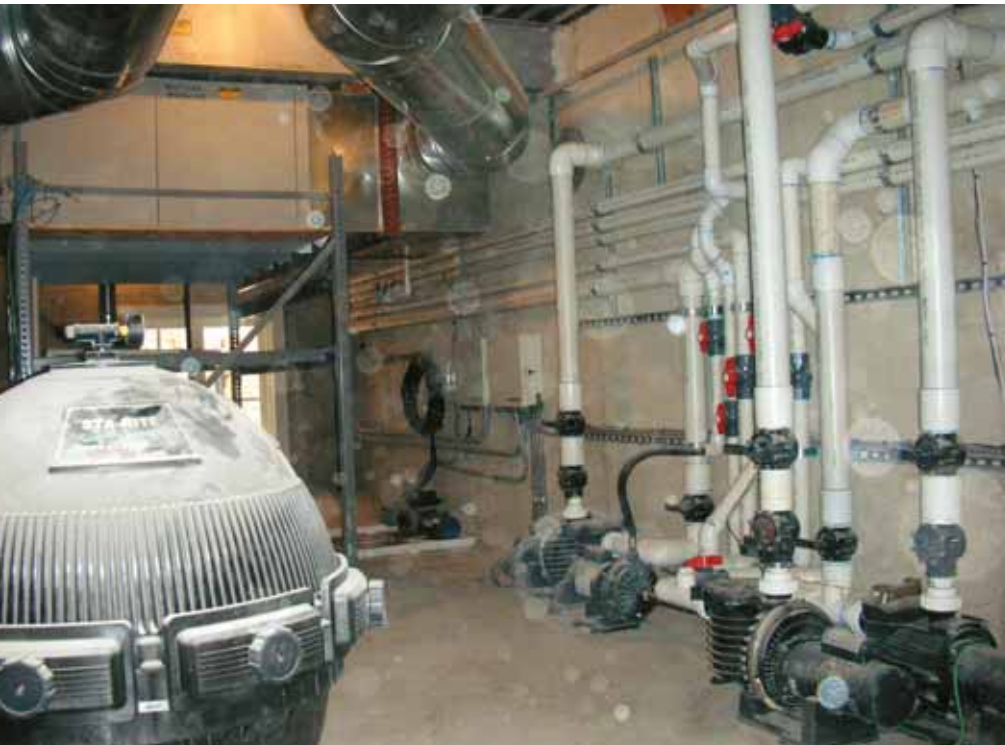
**ABOVE:** *Below the pool patio level, HVAC and dehumidification systems had to share space with the pool mechanical systems. The pool piping and HVAC venting had to be installed in coordinated phases for each to be optimized and operate efficiently.*

The pool and its mechanicals are accessible from a room below pool level so that when repair and replacements need to be made in the future, none of the beautiful rock work or expensive detailing needs to be disturbed at pool level. Below the pool patio section, HVAC and dehumidification systems share space with the pool mechanical systems. The pool piping and HVAC venting were installed in coordinated phases for each to be optimized and operate efficiently. All piping had to be
